# Reaction to fire test report

Test standard: BS 8414-2:2015 and AS5113:2016

Product: 300 mm Thermomass System NC

Job number: RTF200396

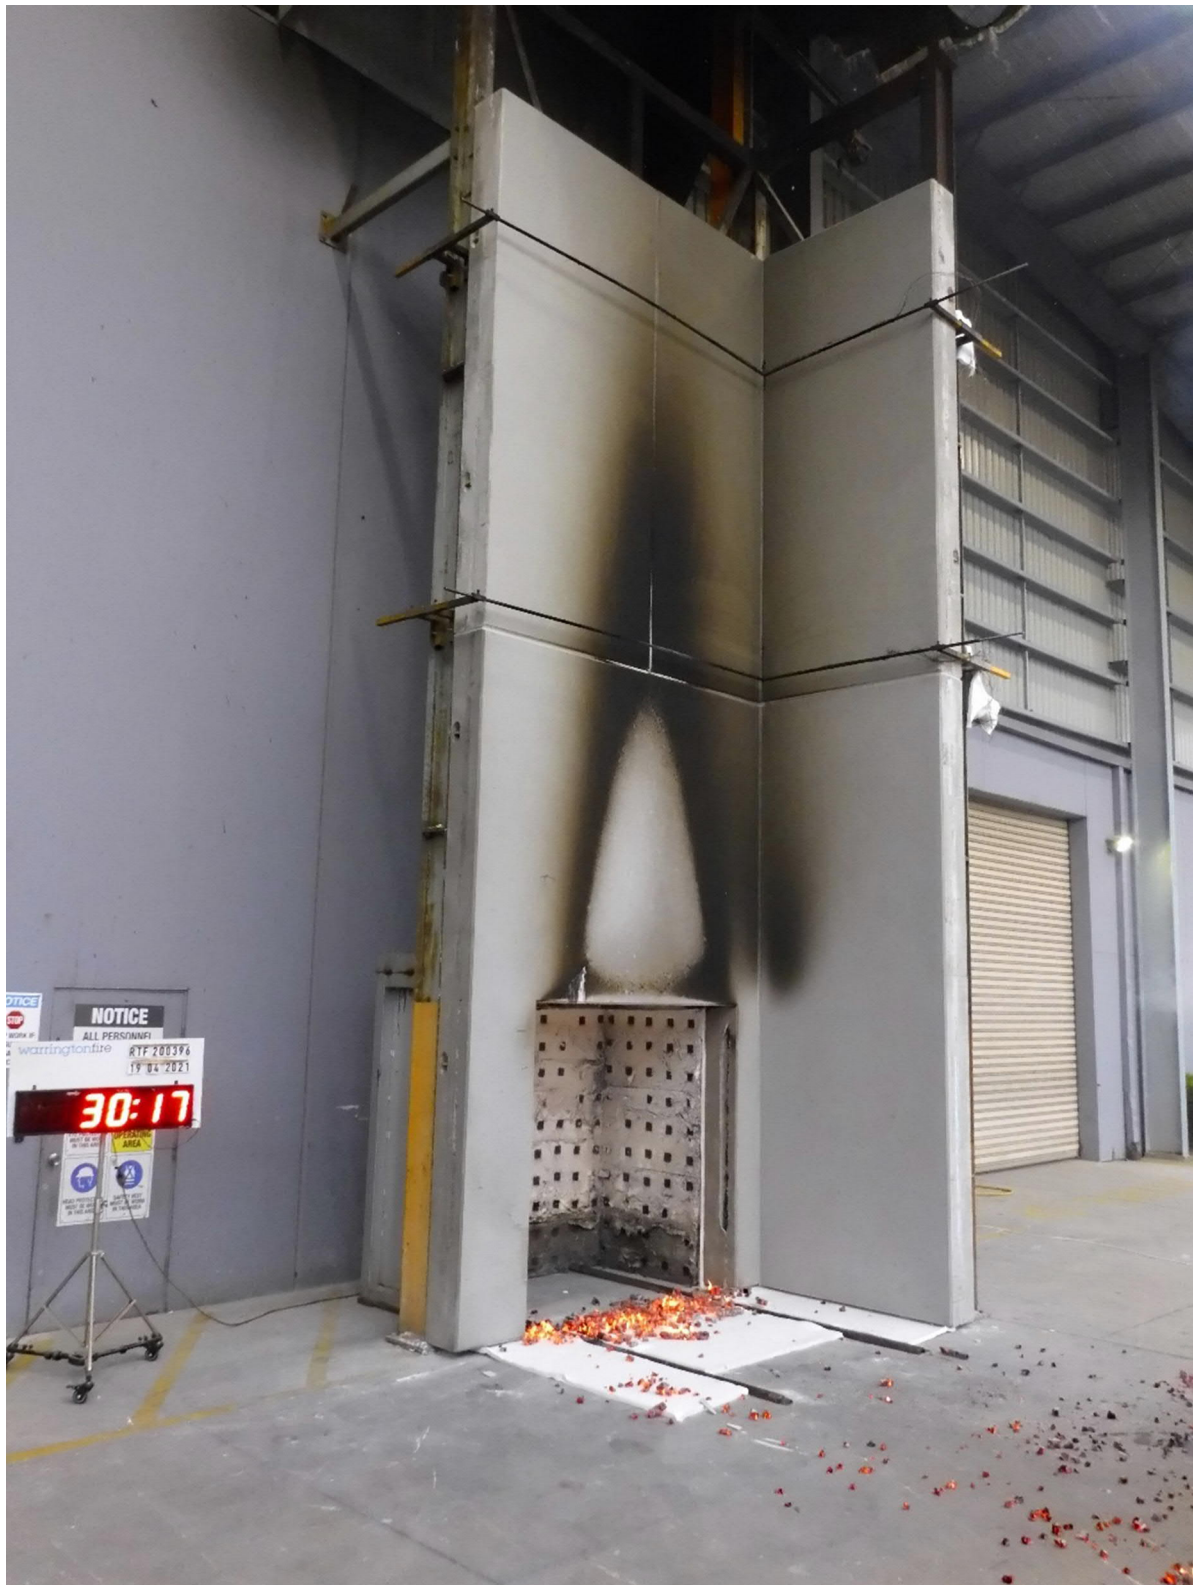
Figure 32 The external wall system during the test –during removal of the crib, 30 minutes after ignition of crib<sup>12</sup>

| Time | | Observation |
|---|---|---|
| 21 | 35 | More of the thin layer of cement covering the XPS on the right jamb detached, with the XPS behind it melting/retracting further. |

<sup>2</sup> Picture shows the portion of the right jamb that detached.

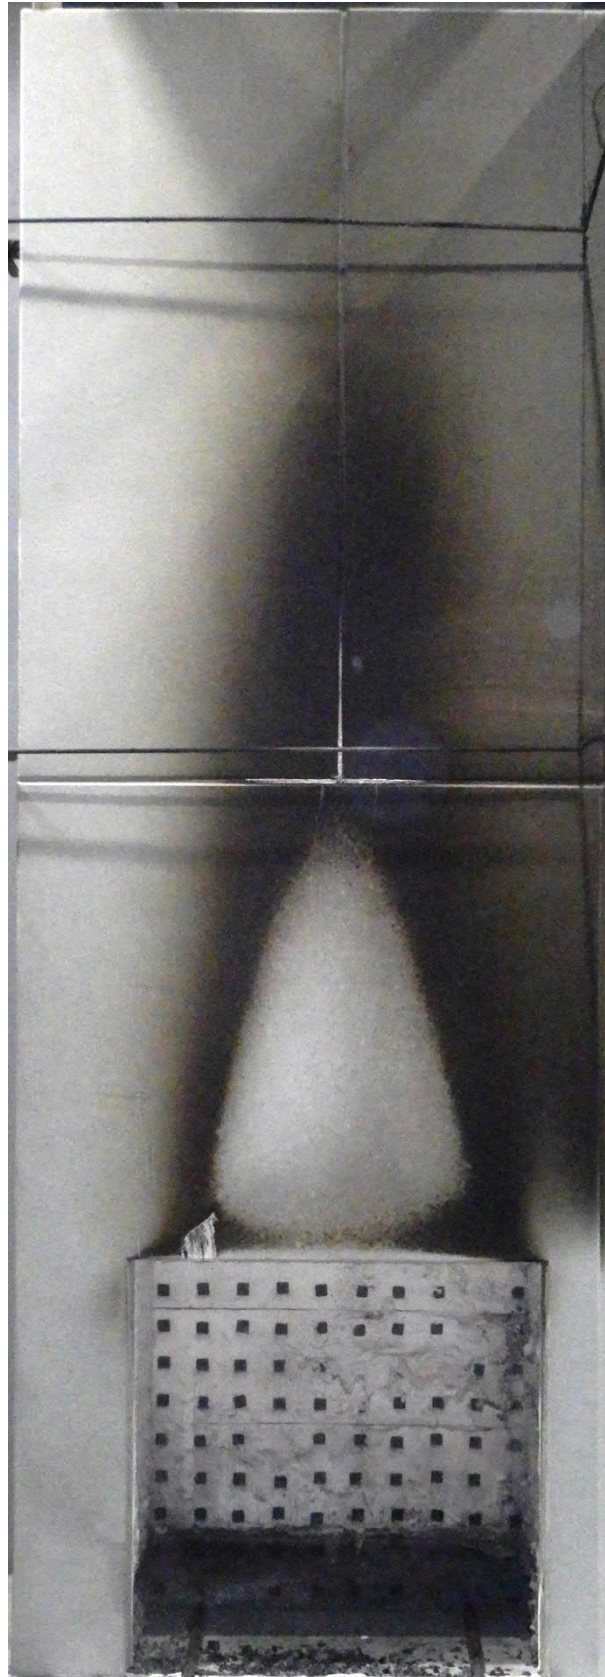
Figure 33 The external wall system on completion of the test – main wall

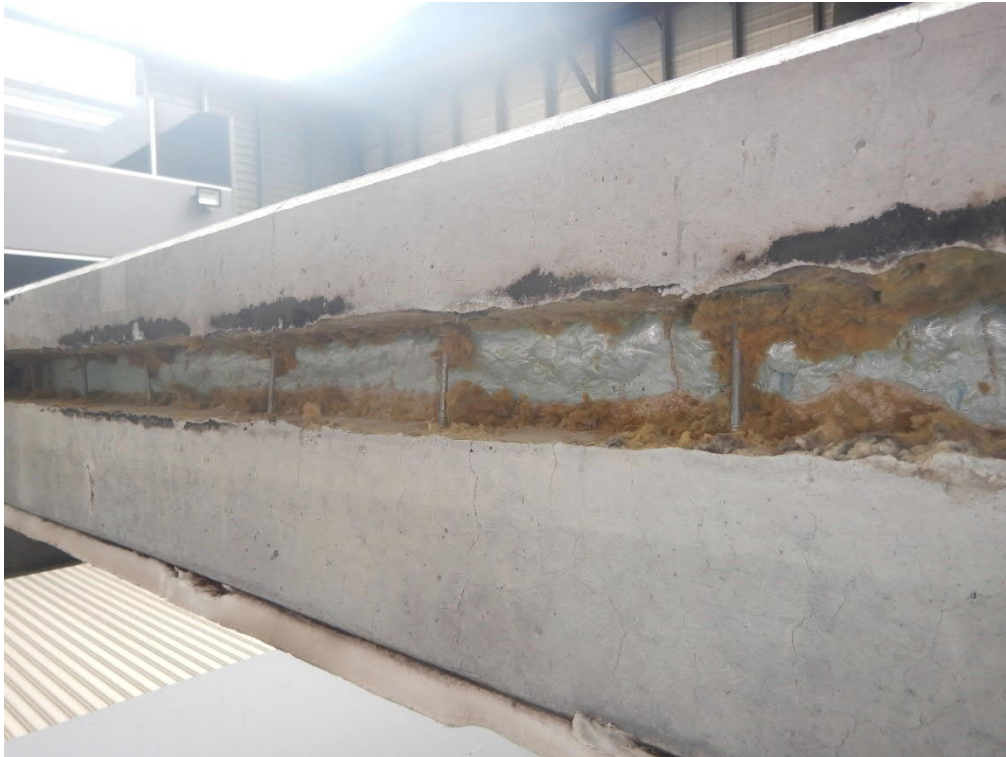
| Time | | Observation |
|---|---|---|
| 60 | 00 | The reaction to fire test was ended. The vertical stone wool above the chamber opening was fully intact. |

- Approximately 6.5 m<sup>2</sup> of panels displayed face discolouration and sot marking from the flames,
- Approximately 1.2 m<sup>2</sup> of insulation had melted or retracted. The insulation behind the stone wool was still intact.

**Figure 35** Condition of insulation behind the stone wool layer above the opening, with the stone wool removed

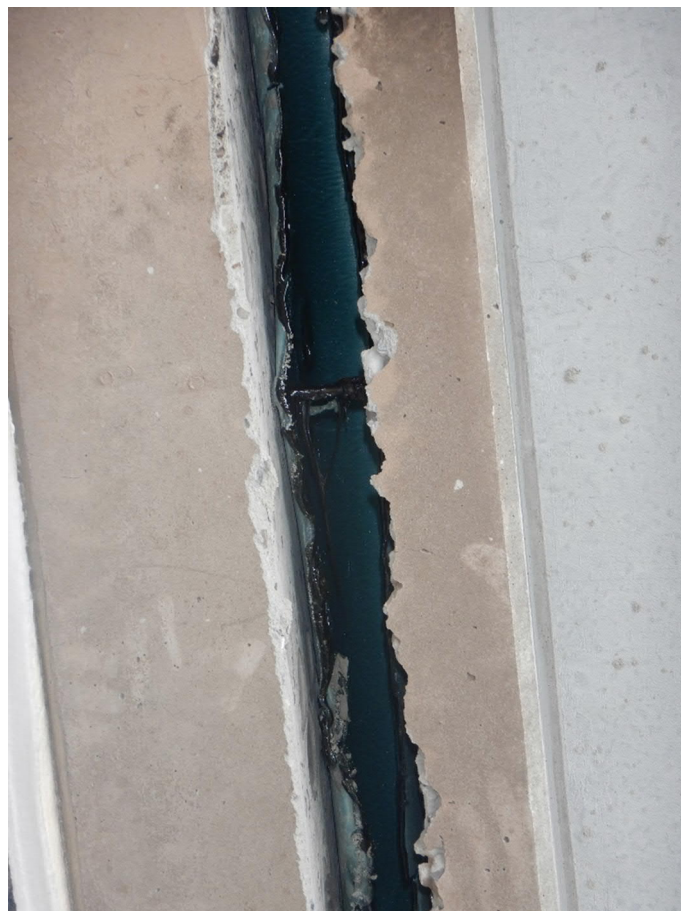
| Parameter | Results |
|--|---|
| <sup>1</sup> The XPS insulation melted/retracted beyond the minimum confines of the specimen, defined in AS 5113 as 2400 mm for the main wall. As no flaming was observed, it is a possibility that the radiant heat from the heat source caused the melting/retracting to occur. Only the side insulation next to the heat source experienced melting/retraction, while the insulation above the heat source did not experience any melting/retraction. | |

Figure 36 Melted/retracted XPS insulation of the right jamb

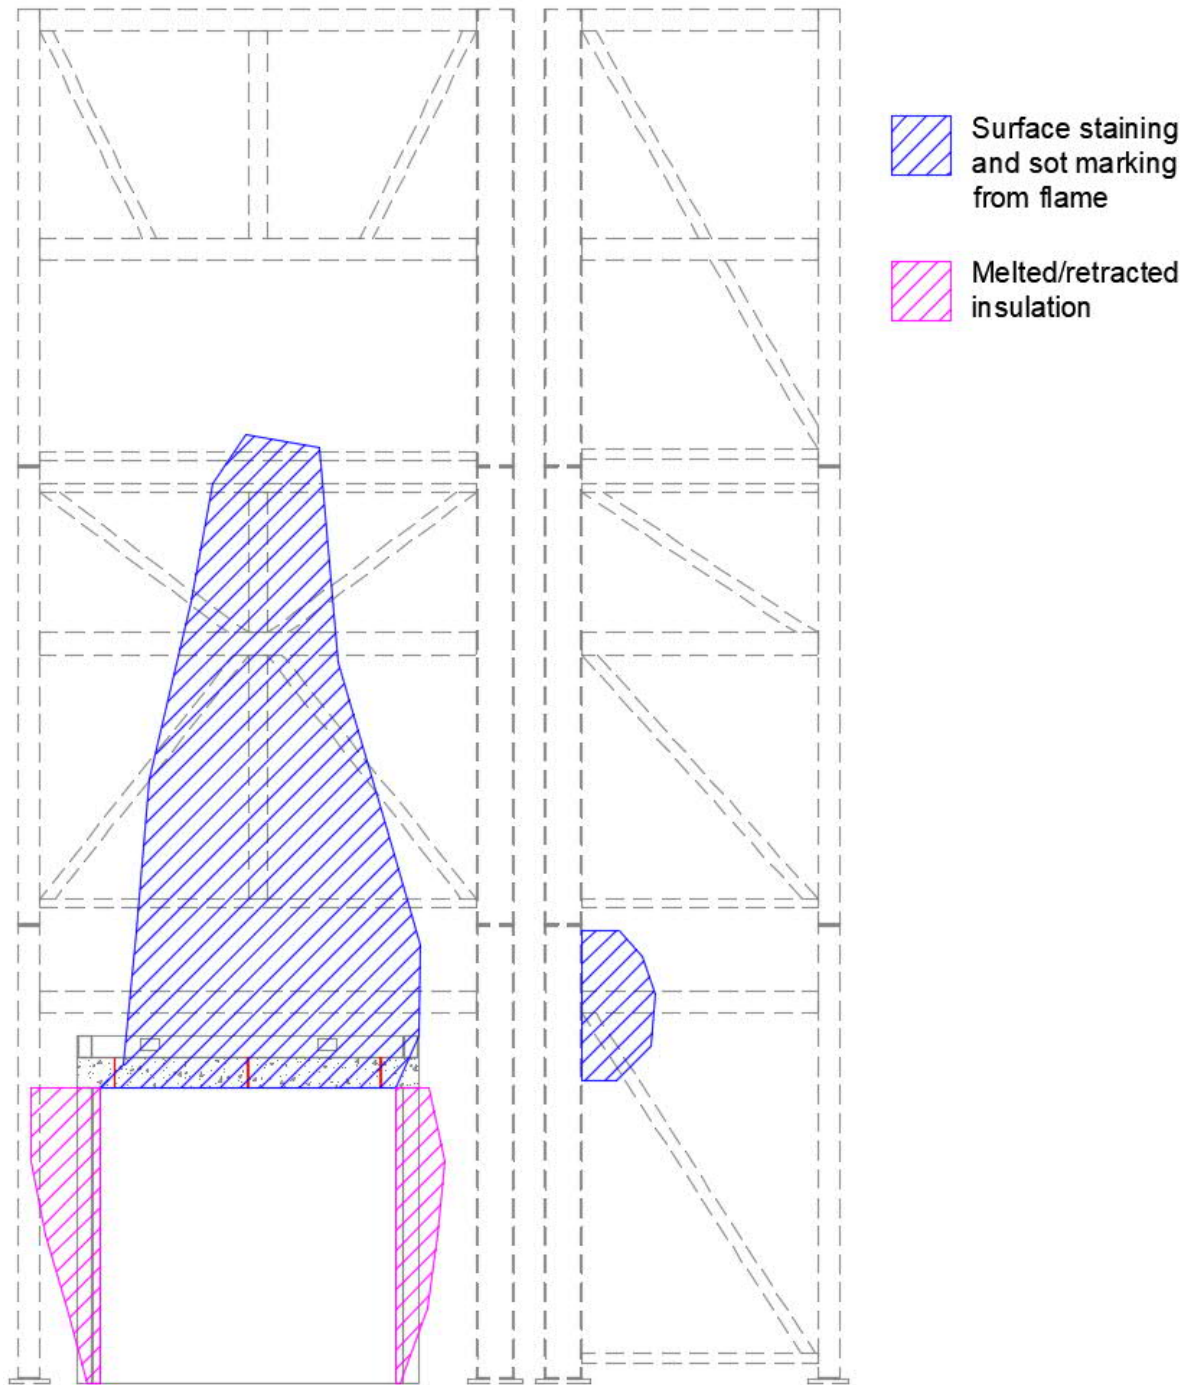
Figure 37 Mark up of the damaged area of the cladding system
